DIEGO GARCIA FLEET MOORINGS INSPECTION REPORT

FPO-1-82(21)

OCEAN ENGINEERING
AND CONSTRUCTION PROJECT OFFICE
CHESAPEAKE DIVISION
NAVAL FACILITIES ENGINEERING COMMAND
WASHINGTON, DC 20374

30 SEPTEMBER 1982

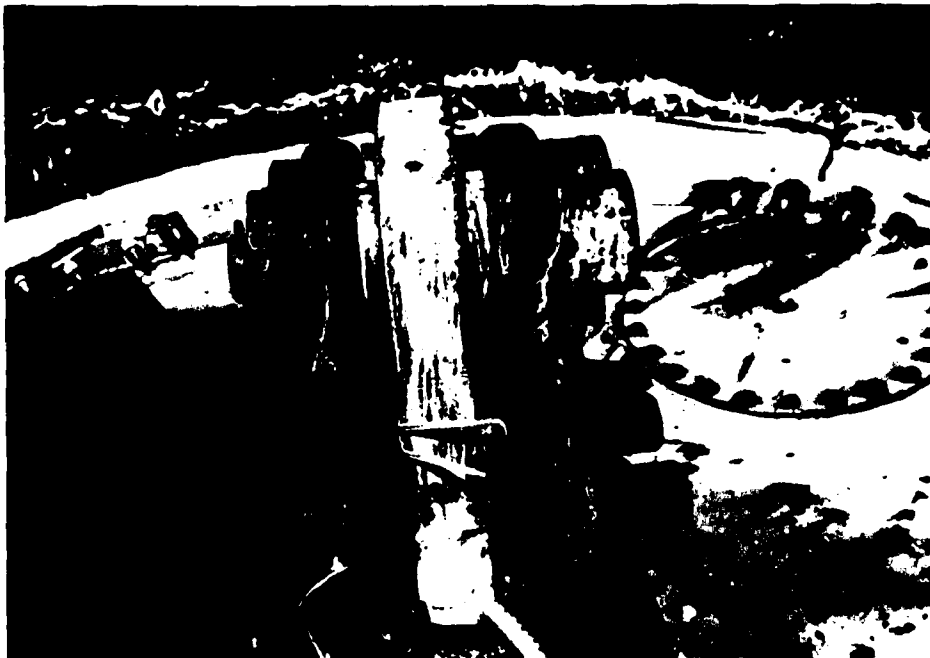
Buoy fenders are in satisfactory condition. The shackle and shackle pin are rusting away in layers.

Topside of buoy has sections of heavy rust.

Rusted shackles and top deck plating of Buoy 11 NW.

Due to the deteriorated condition of the mooring buoys, it is recommended that the upper portion of each buoy be scraped, cleaned, and properly repainted, using specified/authorized materials, as soon as practical. Delays in refurbishing these buoys can only lead to further deterioration. Excessive delays in maintenance actions could lead to the requirement for replacement of the buoys. Both the northern and southern mooring dolphins should be overhauled by removing from the water and replacing all deteriorated chain and connecting hardware.

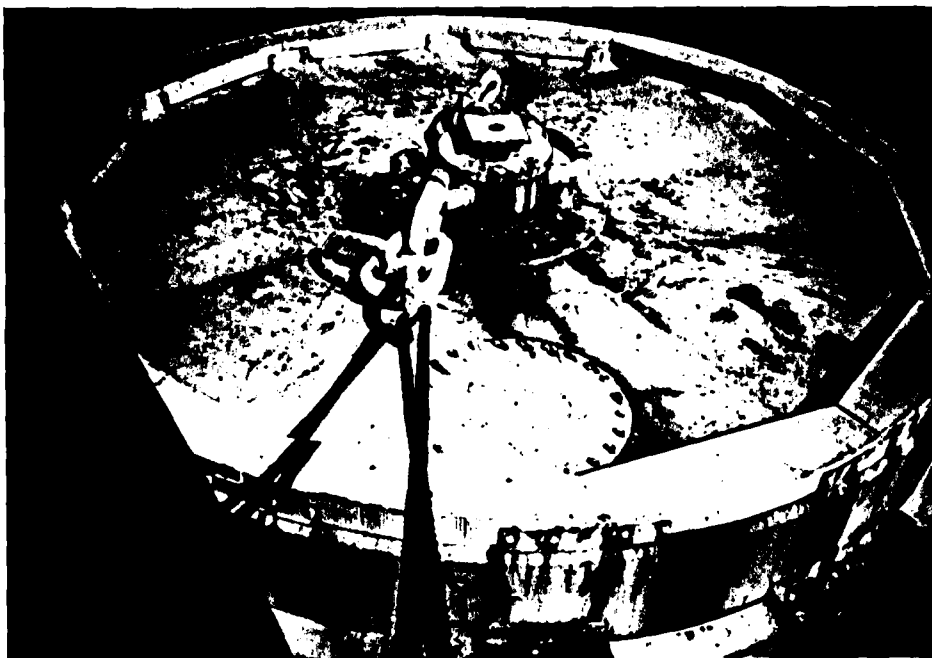
Top of Buoy 7N. Best condition of all buoys inspected.
